DELAWARE RIVER BASIN
MILL STREAM, BURLINGTON COUNTY
NEW JERSEY

LEVEL
SYLVAN LAKE DAM

NJ 00151

**PHASE 1 INSPECTION REPORT
NATIONAL DAM SAFETY PROGRAM**

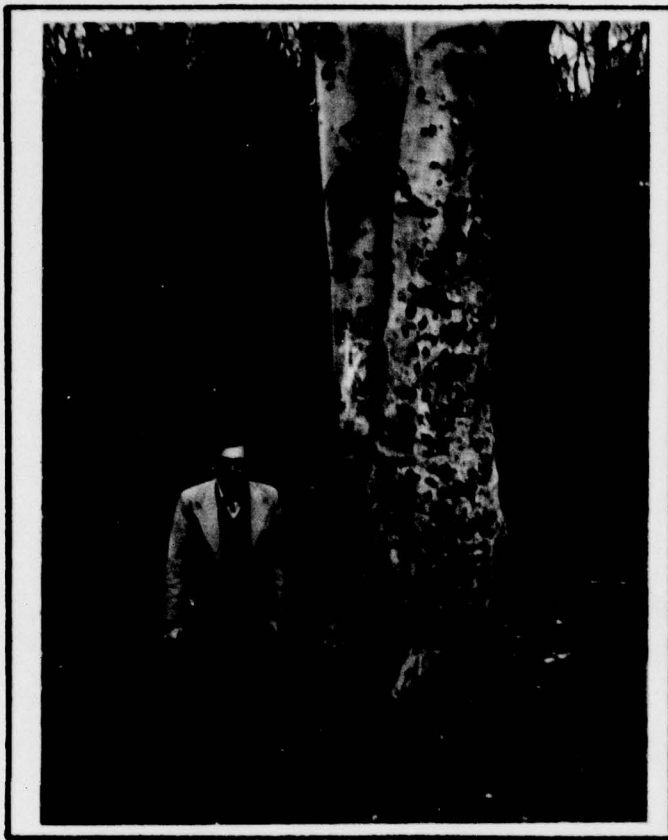
The roots of trees growing on the dam may increase the seepage potential through the embankment and uprooting of the trees by high winds could cause substantial volumes of embankment material to be displaced.

**TYPICAL LARGE TREES
ON DOWNSTREAM SLOPE
OF SYLVAN LAKE DAM**

4. Piezometers should be installed in the embankment and foundation to measure pore pressures.
5. All trees and brush should be removed from the dam and the embankment area where the trees have been removed should be backfilled and regraded.
